FROM THE PRESIDENT

CONTENTS

RADIO WAVES

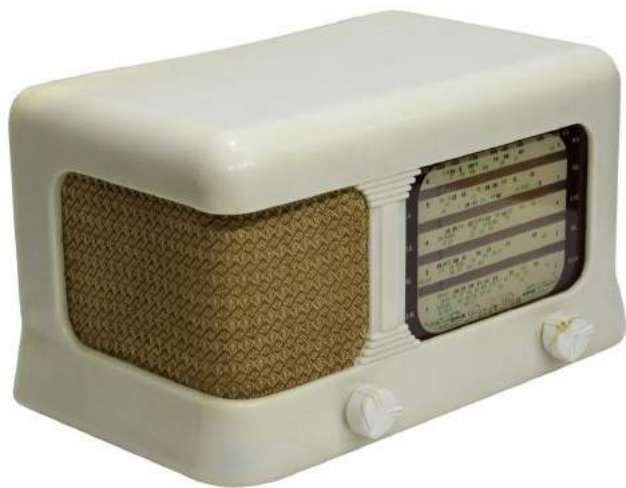
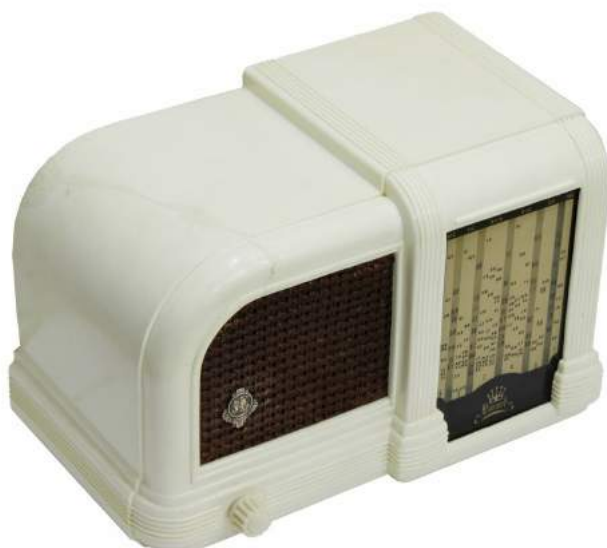
Monarch model DKL and Peter Pan model GKL

The same basic circuit as the Astor KL was used for the radios repackaged as Monarch model DKL and Peter Pan model GKL. As you can see the case work is significantly different and this required different layouts for the chassis and access to the tuning and volume controls.

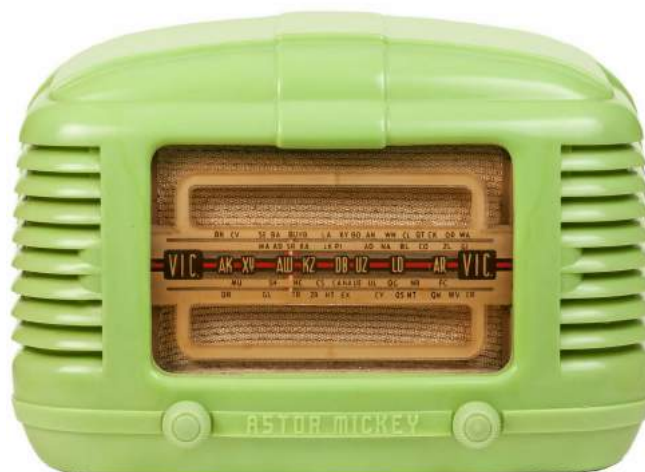
Astor released the popular Mickey model KL immediately after the war in 1946. It was cheap and cheerful, featuring only 4 valves.

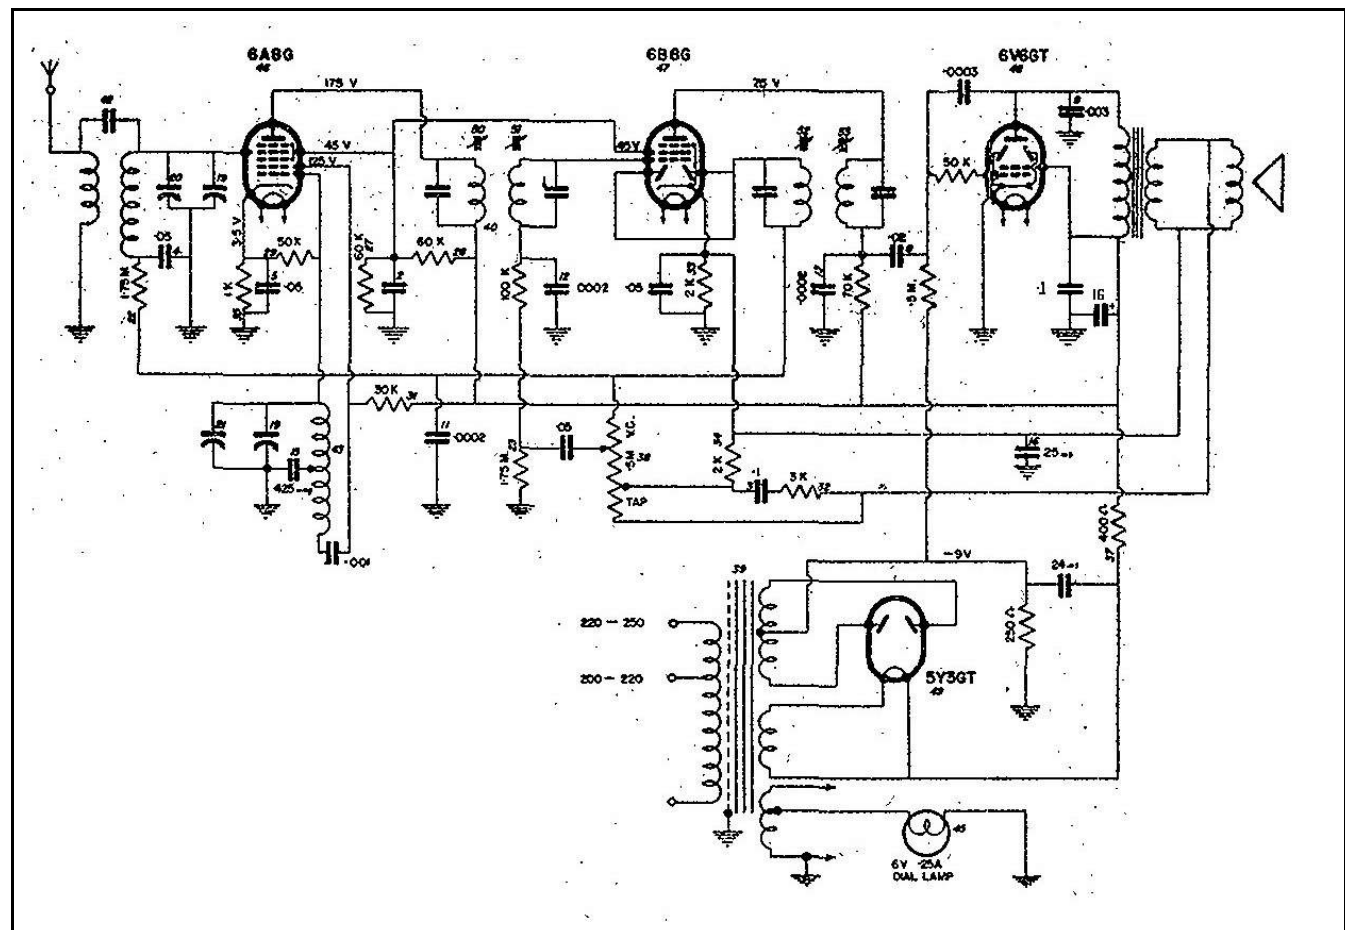
The AORSM circuit for the Astor KL is drawn in a different style and to my eye only three components are different. For the KL the mains transformer has slightly different windings so the voltages are higher requiring a 450 ohm voltage dropping resistor in the HT filter circuit, rather than 400 ohm. The capacitor arrangement linking the primary and secondary of the aerial coil is also different. Other than those minor revisions all circuit details appear to match.

The following description of the circuit has been adapted from the notes published in the 1946 edition of the *AORSM (Australian Official Radio Service manual)*.

A mantel model with 4 valves. It is a reflexed superheterodyne receiver. The circuit which is of unusual design has overcome the usual disadvantages of reflexed circuits, i.e. low-volume distortion and failure of the volume control to cut off. The valve line up consists of a 6A8G pentagrid converter followed by a type 6B8G diode pentode used as a combined IF amplifier, diode detector and A.V.C. bias source and first audio amplifier. A.V.C. is applied to the 6A8G only. Volume is controlled by varying the reflexed audio signal applied to the 6B8G valve. The audio output of this valve is fed directly to the 6V6GT output valve. Negative feedback is taken from the secondary of the output transformer and applied to the bottom of the volume control. A second circuit providing bass boost is connected to the tap on the volume control. Bias for the 6V6GT output valve is

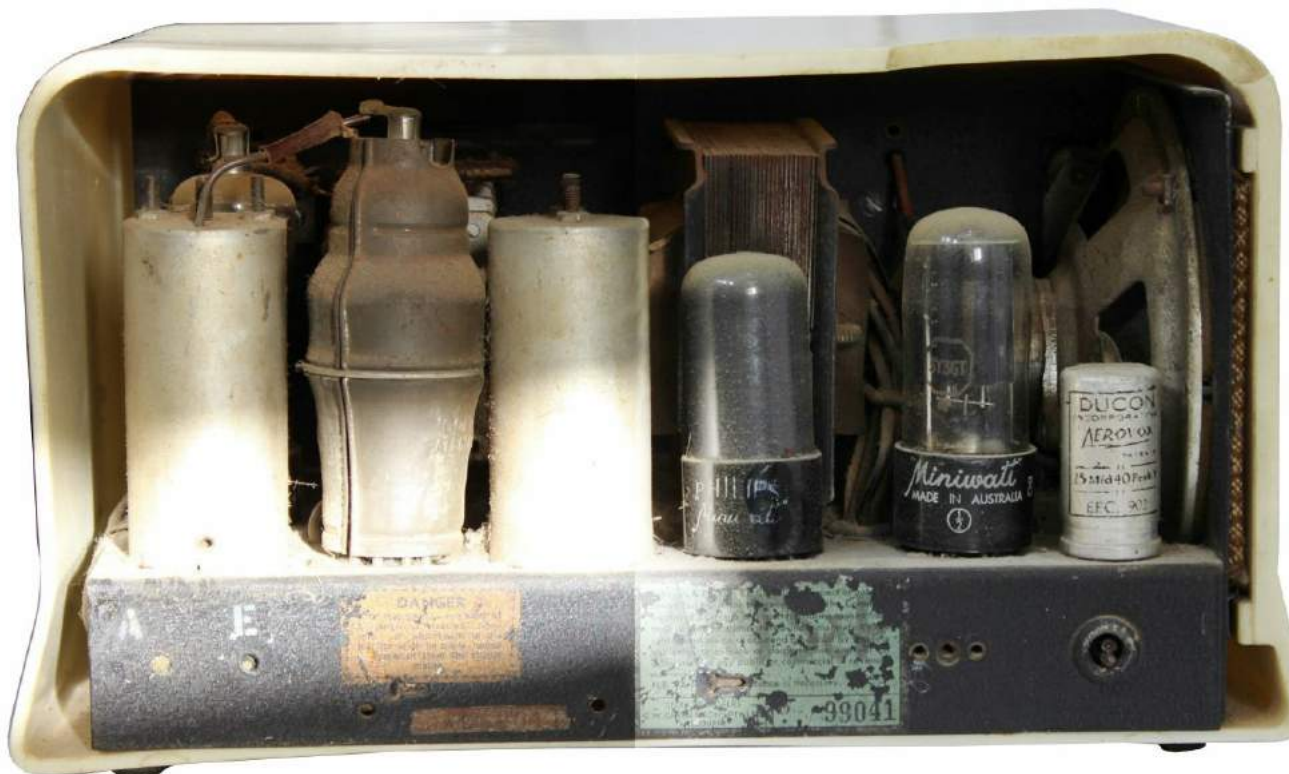
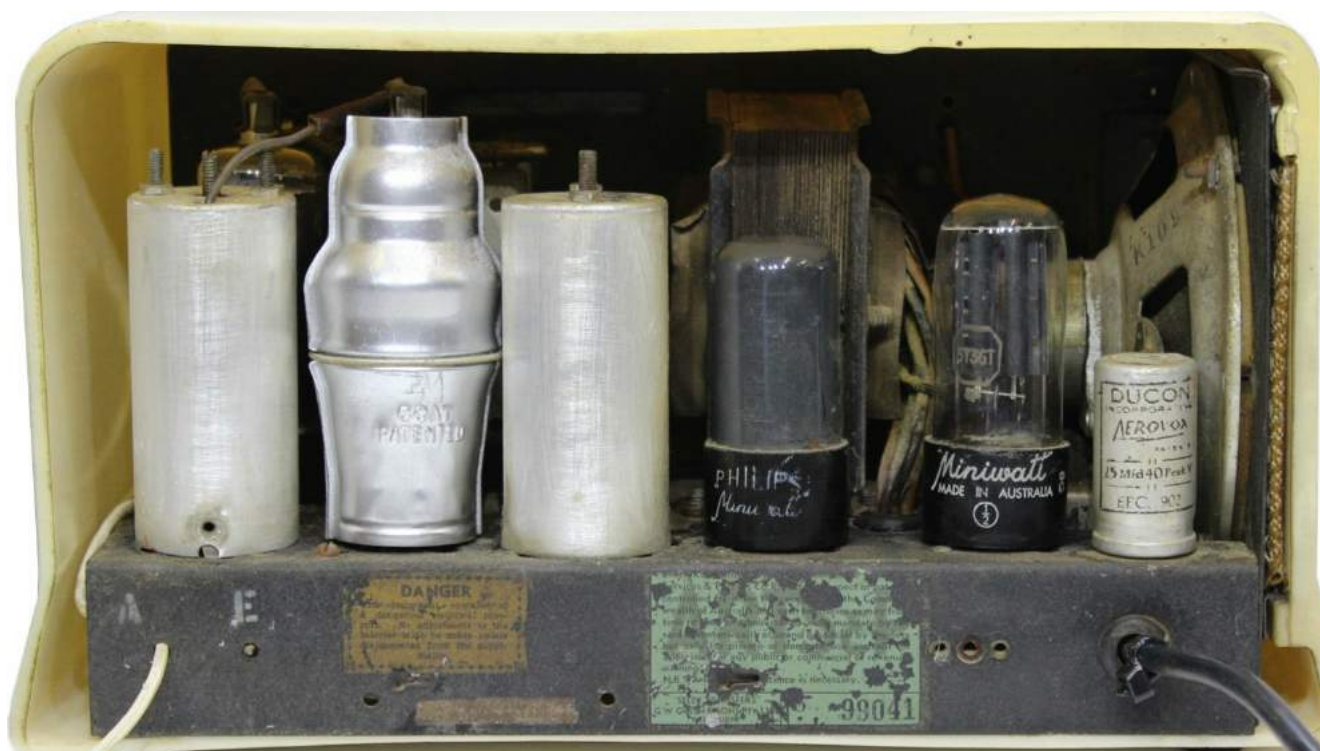
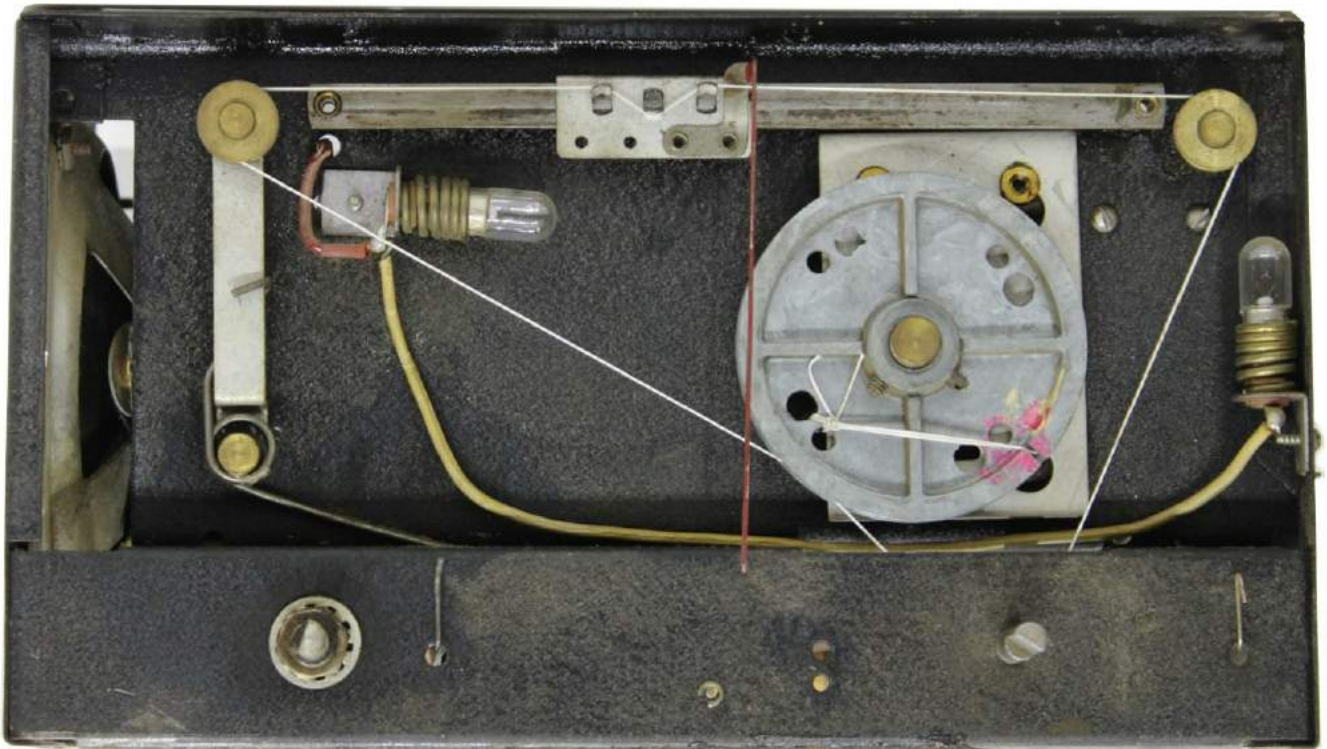
The dial string was broken. Replacement was relatively easy because the dial string has a spring-tensioned arm,

rather than a conventional spring in the dial drum. After the string is in place it is a simple matter to rotate the torsion arm and apply tension.

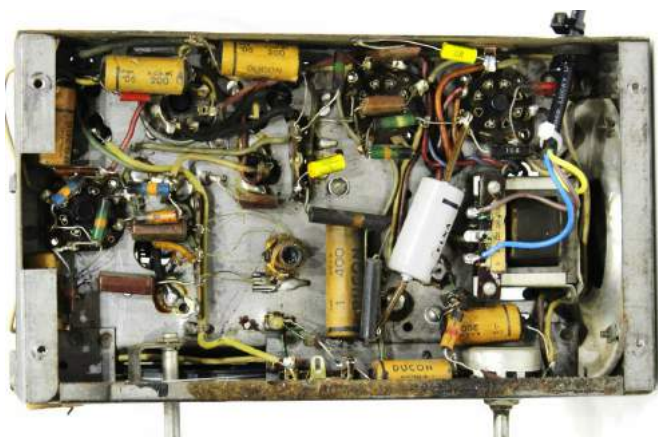
Unusually, the chassis is painted in black-crackle finish.

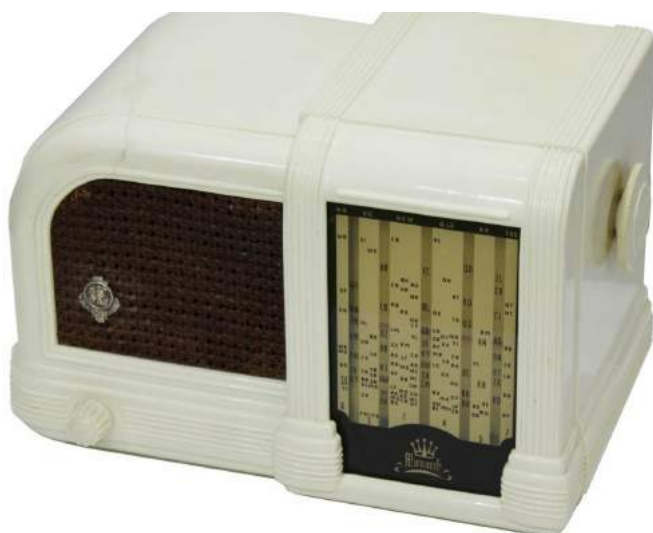
MONARCH MODEL DKL

This is the baby Monarch. The five valve model has a scaled-up case of similar appearance. This example has a crack extending across the left hand top. But it is a minor blemish and it was left alone.

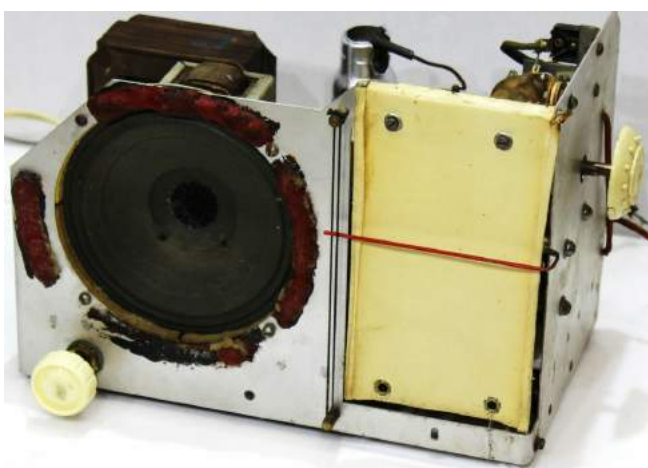
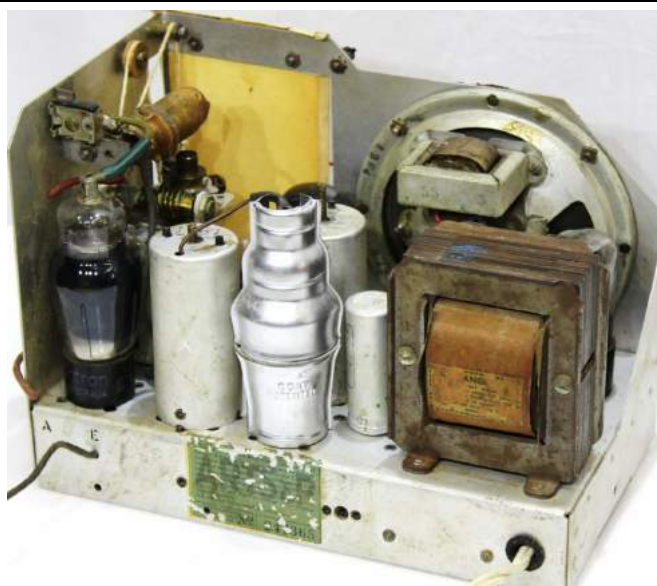
The chassis layout is tight, but not cramped.

The underside of the chassis is well set out for easy replacements. Some critical capacitors had already been replaced so only the plate bypass capacitor to the 6V6 was additionally replaced. The radio performs well within the limitations of four valves and a five inch Rola speaker.

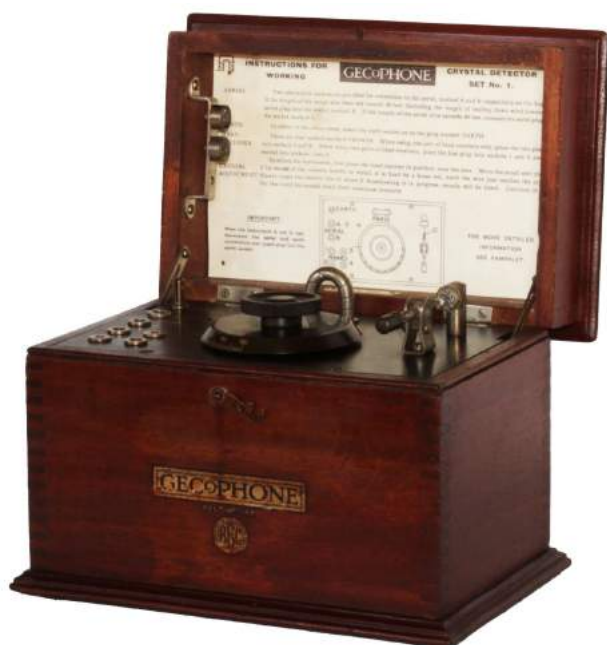
BC1001

Originally introduced in about September 1922, the earliest of this model has 'PARIS' inscribed on the ebonite control panel as opposed to 'LOADING COIL' on later versions. The horseshoe shorting link, which was to become the GEC trademark, could be removed and replaced with a long-wave loading coil used to tune to the wireless telegraphy time transmissions from the Eiffel Tower on 2,600 metres. Early versions also have an ebonite coupling tuning dial engraved 0 - 180° as opposed to the later bakelite dial with the same inscription. Early versions of the mahogany case have clearly visible screw heads holding the lid to the sides.

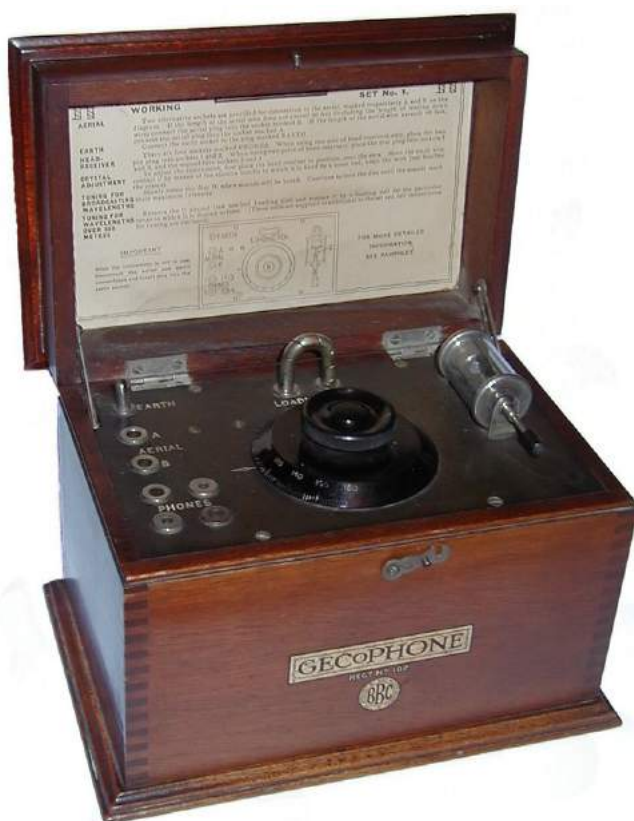
BC1002 - Lorne Clark's collection

Specification – Deck of high-grade matt ebonite, fitted with plug and socket terminals for aerial and earth connections, and sockets for two sets of telephones. Tuning is by variometer, covering 300-500 metres, and sockets for the addition of loading coils for higher wavelengths, such as that of the Chelmsford Station, are provided. Detector is a 'Gecosite' specially sensitive crystal enclosed in a dust-proof glass cover. The whole instrument is fitted in a highly finished mahogany cabinet with cover, and all metal parts are heavily nickel-plated. Supplied complete

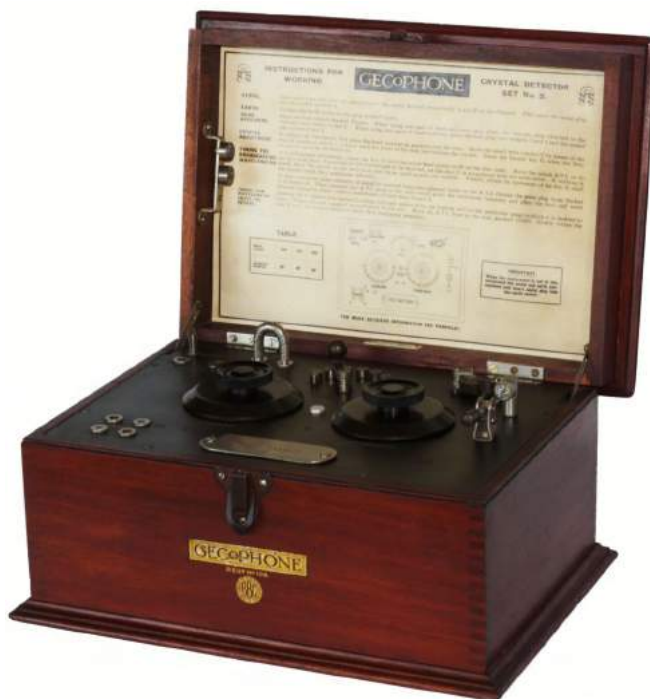
BC1501

Specification – For more selective tuning than Crystal Set No. 1. This set has a coupled circuit with adjustable coupling. Aerial tuning is effected by a tapping switch and the closed circuit is tuned by means of a moving plate condenser. The detector is a 'Gecosite' crystal, which is specially sensitive and does not require a potentiometer or battery. Fitted with a testing buzzer and key so that the crystal may be adjusted to its most sensitive position. Constructed for wavelengths of 300-500 metres, and fitted with sockets for the addition of a loading coil to give longer wavelengths if desired, and for the reception of the Paris Time Signal. Supplied complete with one pair of 2,000 ohm, double-headgear telephones, and fitted with sockets to take one extra pair of telephones if required.

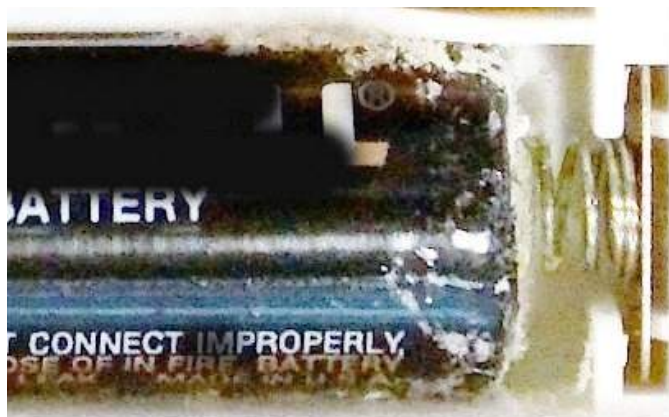
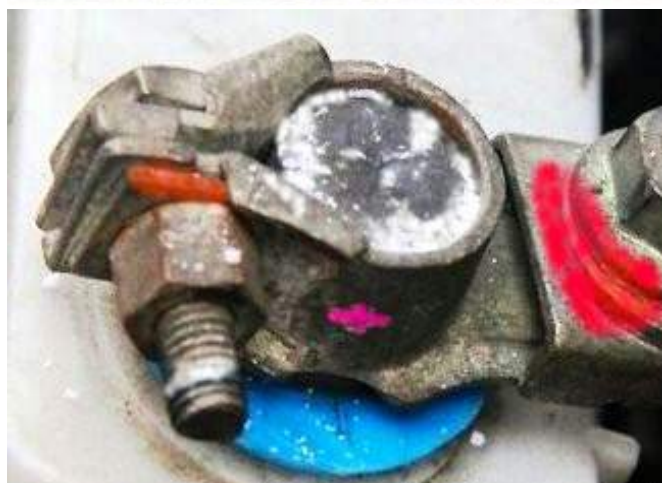
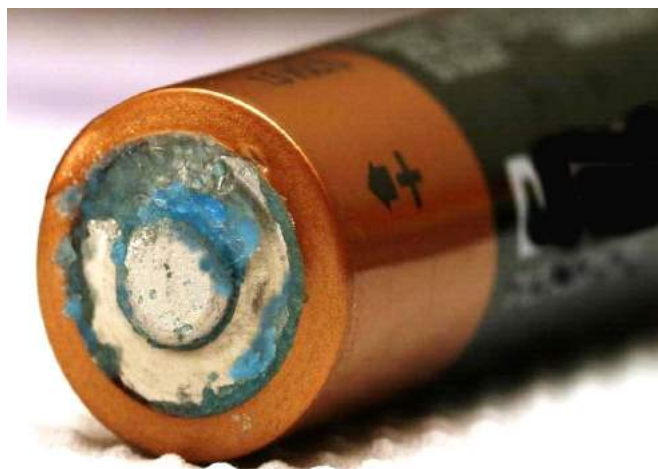
With an alkaline battery, scrape off excess and treat with vinegar. On a car battery, scrape, then use soap or baking soda. Wash off excess with hot water, dry fully, spray with RP7 or WD40*. It is normal for a fizzing chemical reaction to occur. This is OK; simply wait for it to die down.

For alkaline batteries, take care to apply the vinegar or acidic solution *only to the corroded area*.

As before, a sharp screwdriver blade may help to scrape off the excess blue-green corrosion. Once finished with the acid treatment, wash it thoroughly with warm water, and then dry it (remove all acid).

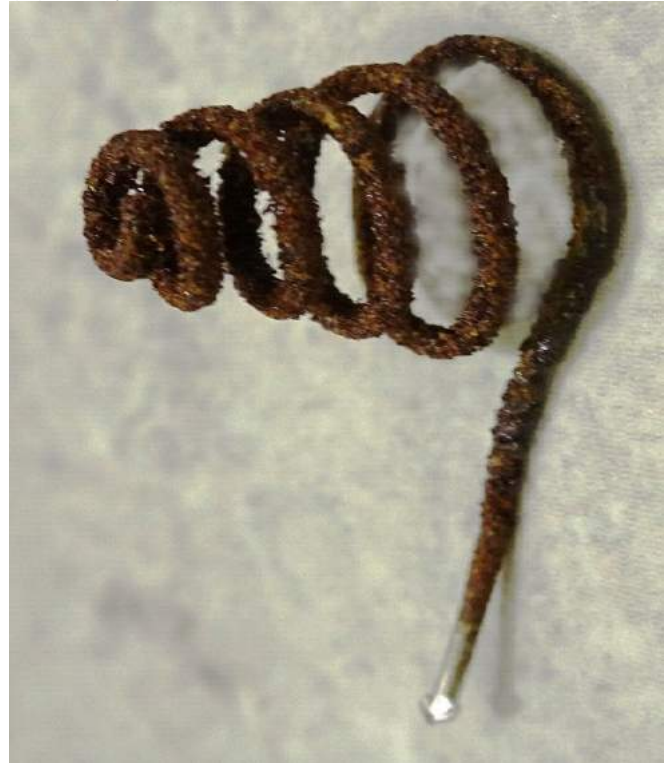
Rusty contact

Rust removal: Scrape off excess, try soaking in vinegar from an hour to a day with a small 2cm sheet of aluminum foil. I have found limited success this way. Try CLR from Woolworths or Bunnings, (again, limited success found), or a product from Spotlight, 'Magic Metal Cream' (untested). Finally, try about 10ml (2 teaspoons) of oxalic acid with 100ml of warm water, soak for 24

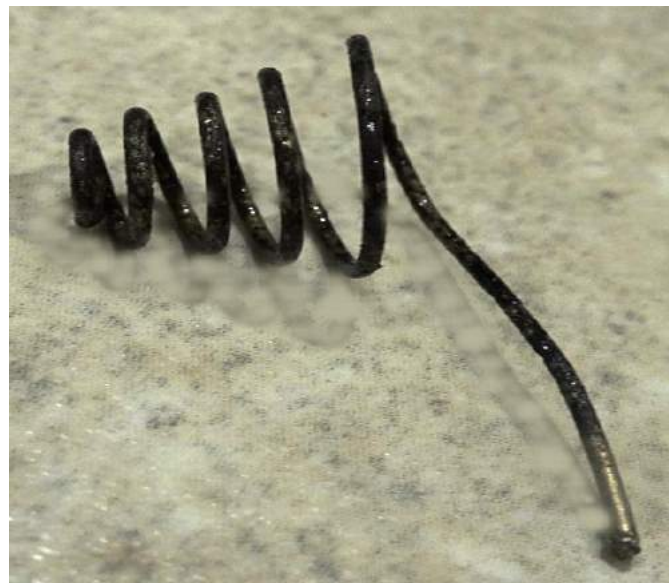
Soaking in Vinegar, 1 day

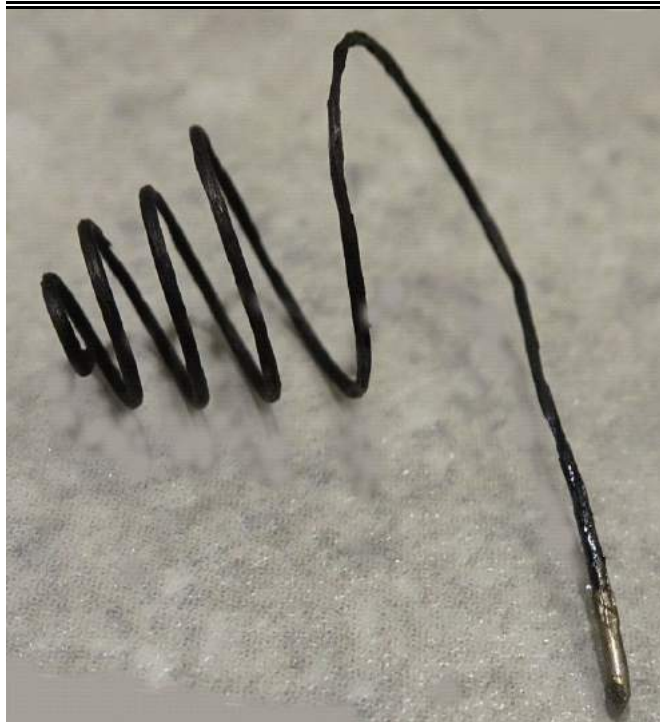
Vinegar for a week

hours, monitor it periodically. Rust converter paint is generally not suitable, as the paint is an insulator and useless for battery contacts

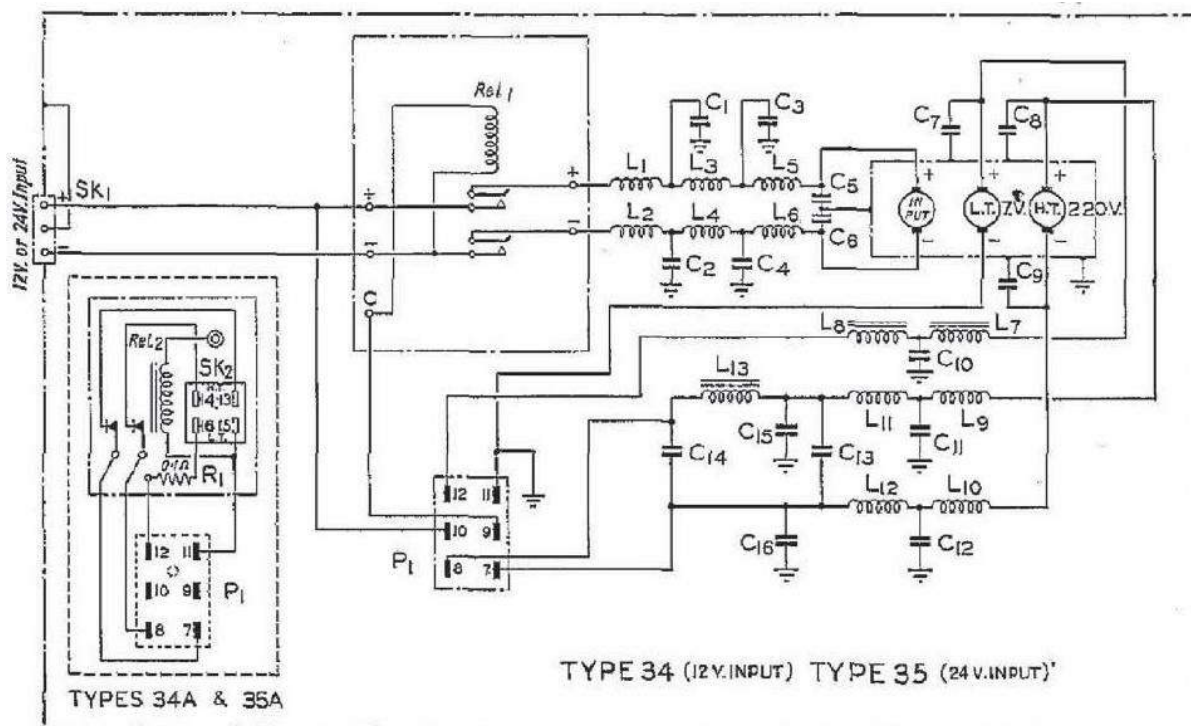
Low Voltage Circuit

AP1186 shows the RF input choke as 3 separate chokes. All power supplies I have seen have been modified to a 2 section choke. The capacitor C5 has been rewired to be in parallel with C3 (effectively 6 uF), and similarly C6

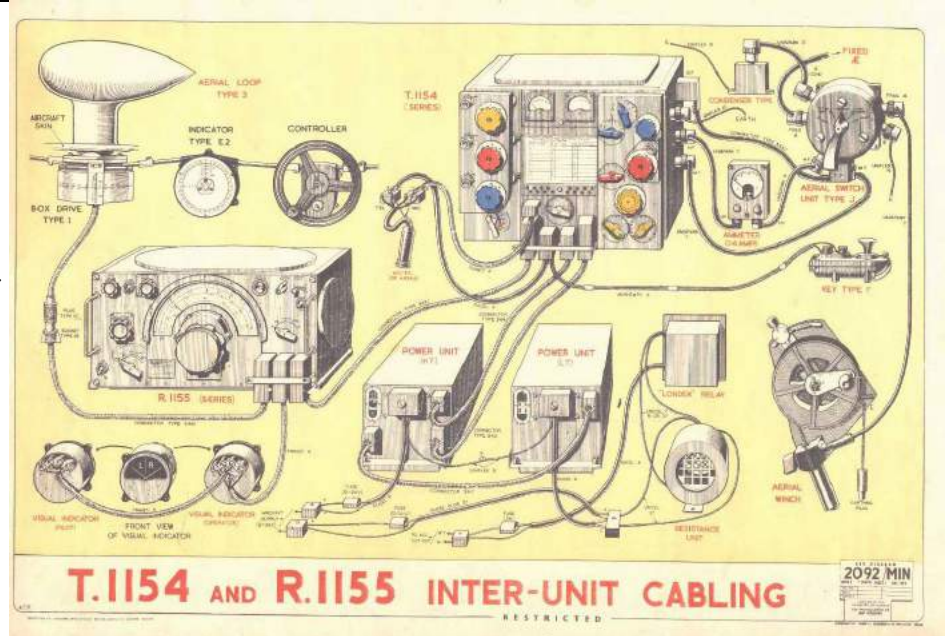
Cabling Diagram

Therefore the resistance unit must be set for each individual installation. The starting current is in the order of 100 Amps. The adjustment procedure, is to measure the accumulator voltage (on charge), measure the heater voltage at the transmitter, and the resistance is then adjusted to provide 7.5 volts at the transmitter. An

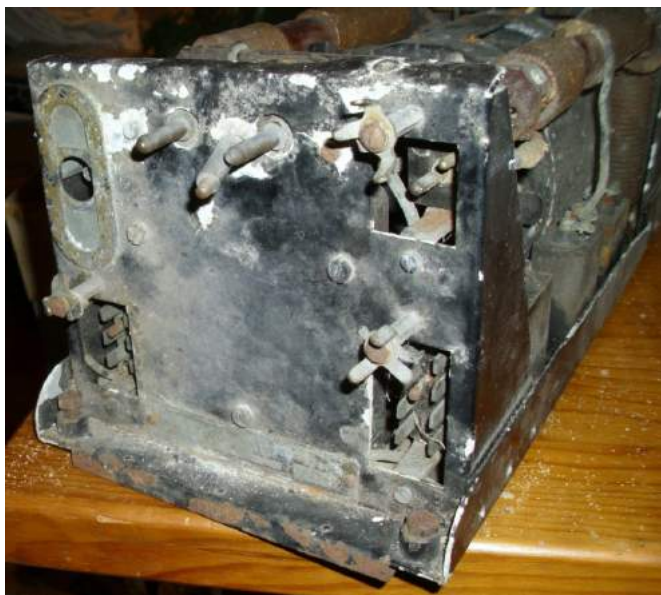
HT Unit (original)

When received, the HV power unit was complete, but very dirty, and missing the top cover. It was cleaned thoroughly, the bent parts straightened, and the outside repainted. The inside was not repainted. A new cover was made. The wiring was checked off against the circuit, wire by wire. It was complete with no wiring changes. This model has the modification for 2 receivers so it is the Type 32A. Each component was measured and checked for value. All the joints (especially in the high current path) were tested for low resistance. So were the joints to chassis for the RF filters. The bearings were lubricated, and checked for free rotation. The brushes were removed and the commutator cleaned and burnished. It was checked for short circuits.

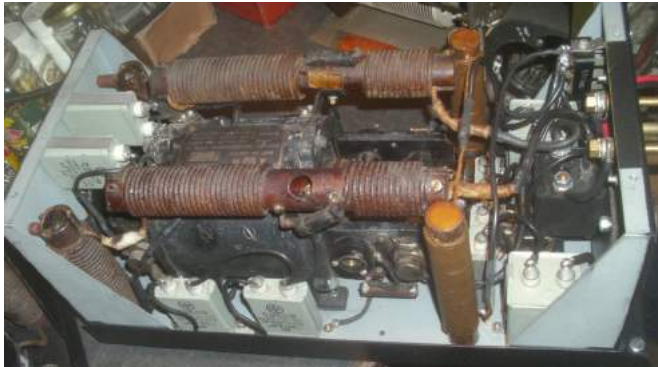
LV Unit Inside

I greased the bearings of the rotary transformer, and powered it up. When I was happy with the performance, I bolted it into the case. I added the capacitors and chokes,

and wired it up as per the manual. I used a resistive load to test the high voltage and low voltage outputs, under load.

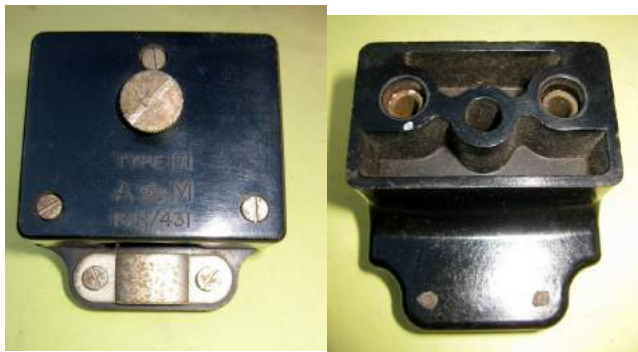
Input Plug (Type 171) (front L) & Input Plug (Type 171) (back R)

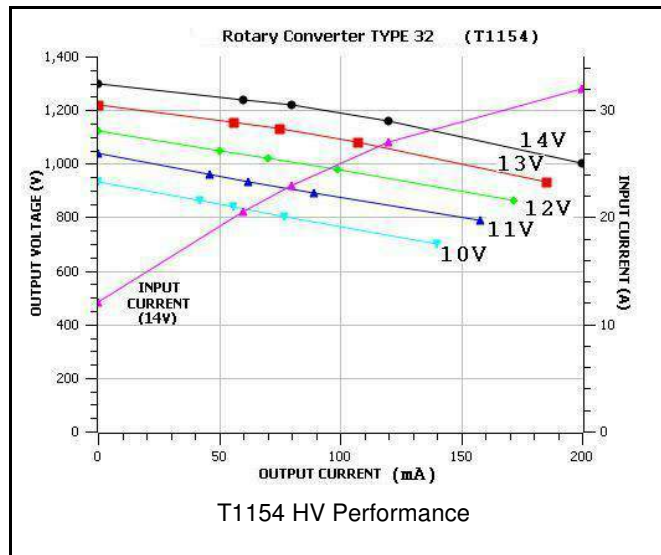
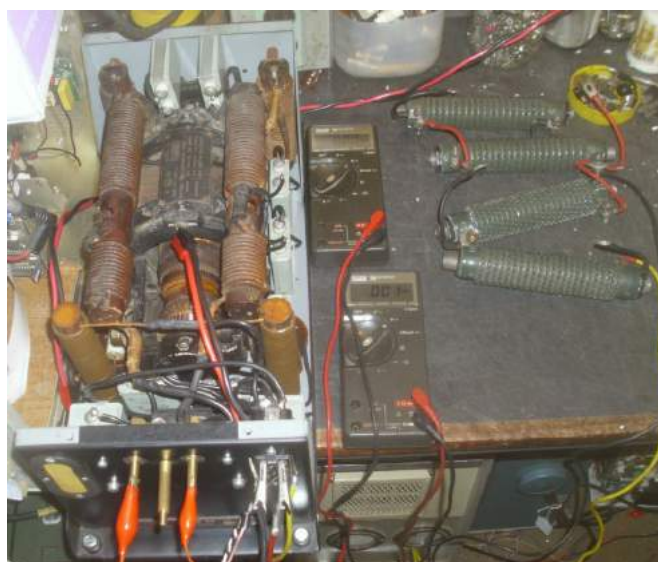
HT Performance

Both power supplies are featureless heavy black boxes. They contain a rotary transformer and filtering. I have tested the 12 volt versions, and provided performance curves. The 24 volt versions would have the same characteristics, but draw approximately half the current,

and be more tolerant of cabling and connectors. The regulation is in the order of 18 to 25 percent. The variations in LT voltage are a problem, as is recognized in the manual text. The control of this LT output voltage by changing the input voltage (at high current) is not very elegant. An inbuilt regulator of some design would be more beneficial, and perhaps increase the life of the valves. It would be wise to have an earth strap between each unit and the transmitter (and connected to earth), not only for the RF present, but as a safety precaution in the possible case of a broken wire or poor connection in the 1200 volt circuit. They are not very common.

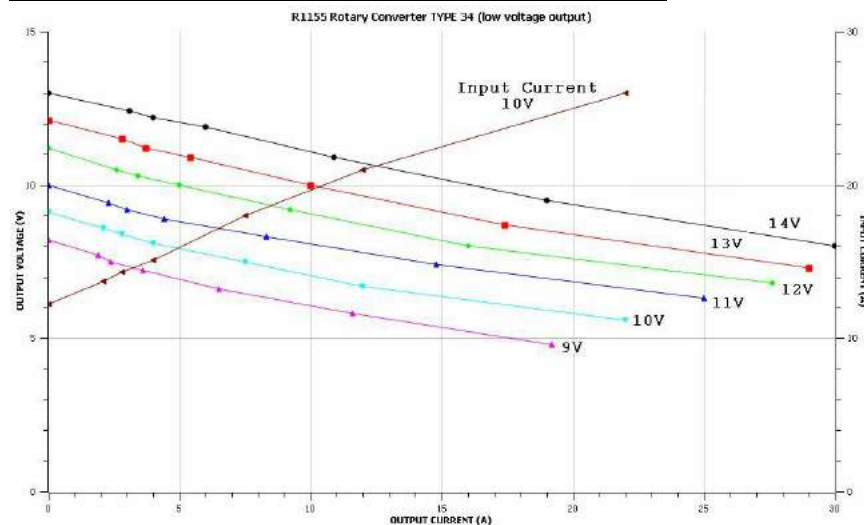
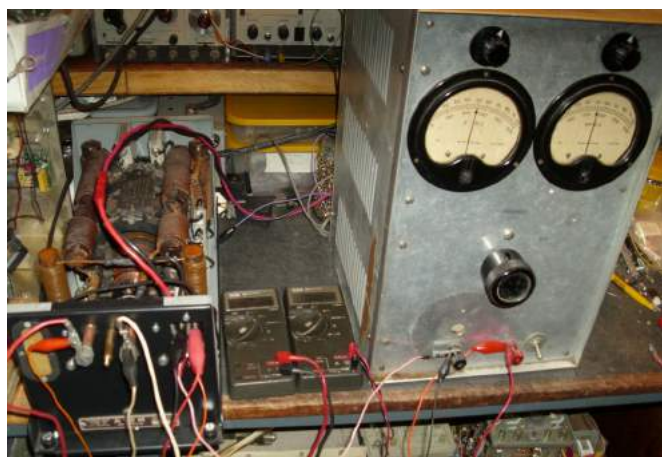
Testing HT

The low voltage unit was also tested with a resistive load. The LT load was several 1 ohm 300 watt resistors, which were connected in series/parallel to provide the appropriate current load. The HT load was a large potentiometer in a box, with 2 built in meters. The HT and the LT were plotted separately. The LT conditions of 7 volts at 13 Amps was met, with a 10 volt input at the unit terminals. The HT voltage for that same 10 volt input was 220 volts at 100 mA.

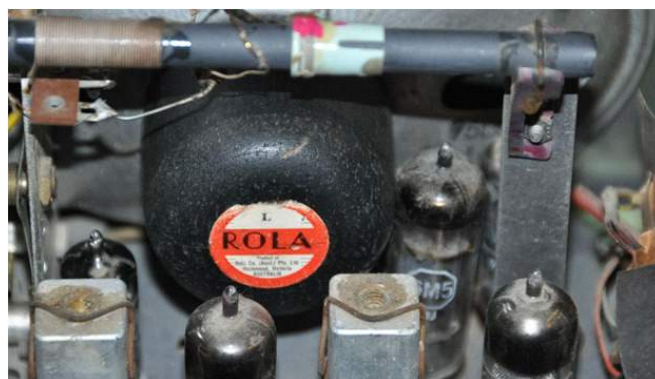
A careful check of the speaker showed the 6M5 output valve was touching the speaker magnet.

This could be the problem, with the magnet losing part strength at a lower temperature. Another possibility is warping of the speaker frame at the higher temperature. Whatever the cause, the solution was to replace the speaker with the 57H. After several hours of operation there was no apparent distortion.

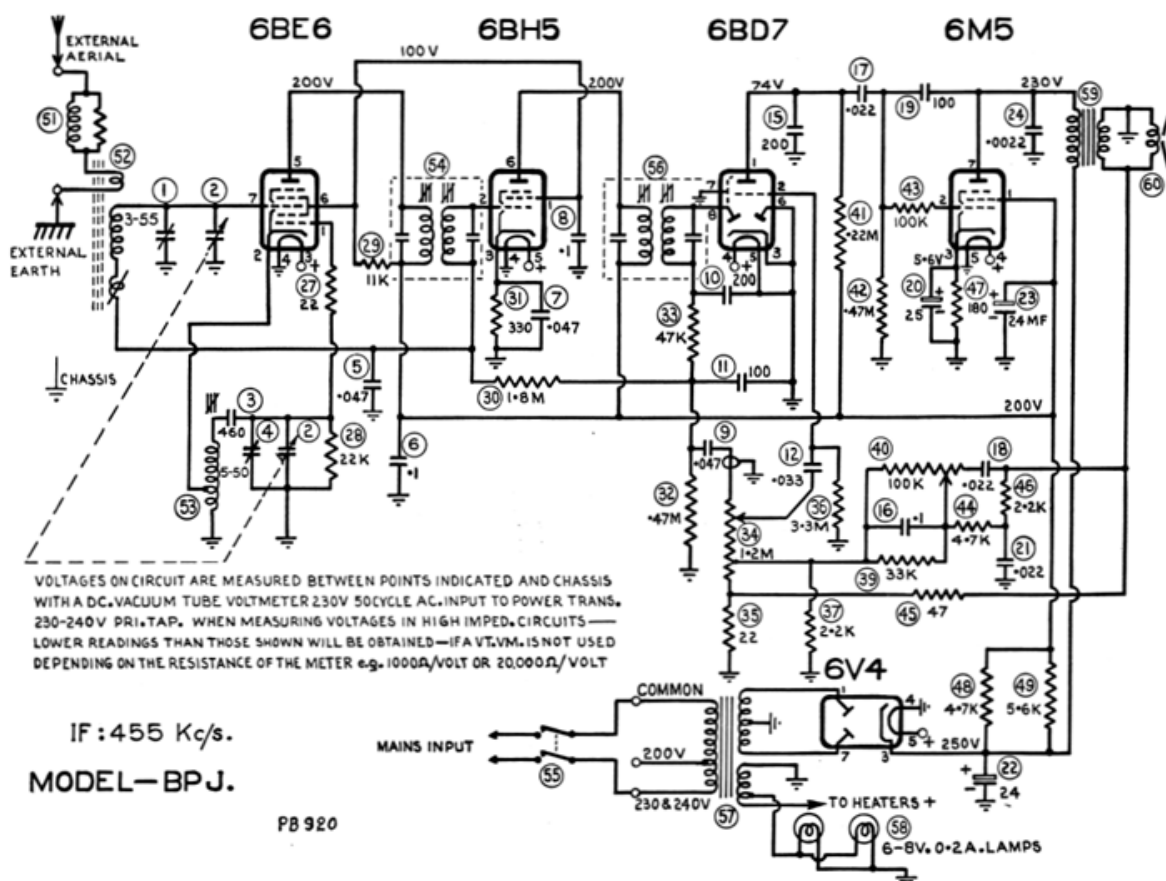
IF. ALIGNMENT.

Operation No.	Generator Connection	Generator Frequency	Dummy Antenna	Instructions.
1.	Remove receiver chassis from cabinet as detailed in the following pages of this bulletin.			
2.	To signal grid of 6BH5 valve (pin No. 2.)	455 Kc/s.	0.01MF Mica capacitor in series with generator	Leave grid wire attached to valve socket. Peak 2nd I.F. trans. pri. and sec. for max. output.
3.	To signal grid of 6BE6 valve (pin No. 7)	455 Kc/s.	0.01MF Mica capacitor in series with generator	Turn tuning control until condenser gang plates are fully out of mesh. Leave grid wire attached to valve socket. Peak 1st I.F. trans. pri. and sec. for max. output.
4.				Repeat operations 2 and 3.

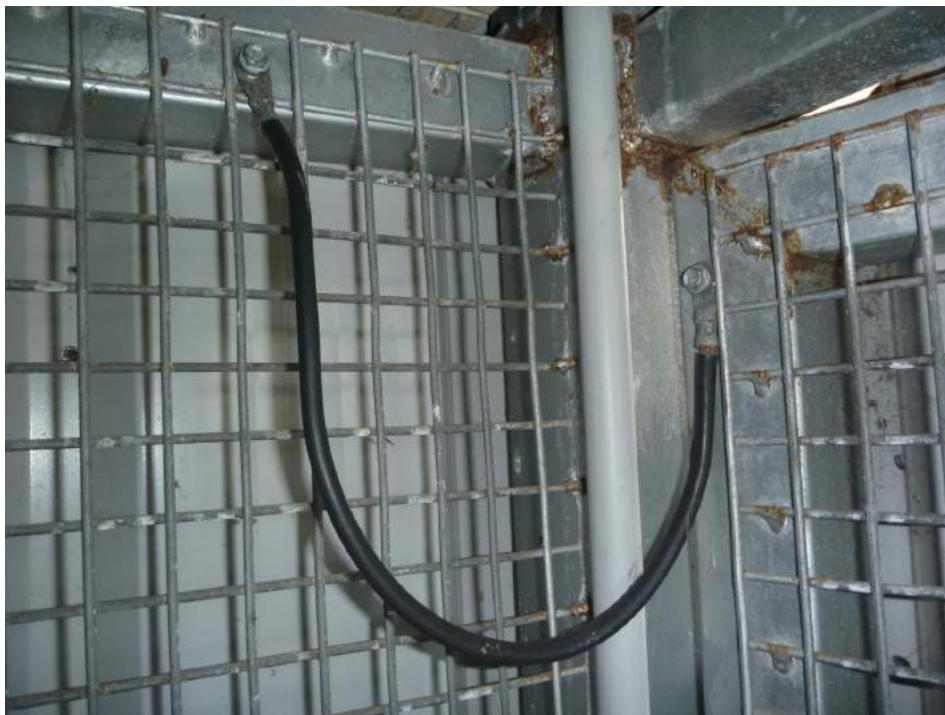
This was achieved by adding 'bond wires' (see Photo 1) to hinged sections, which then formed a complete (i.e. electrically connected) enclosure around all RFI producing equipment (other than the roof mounted solar panels and the main power leads to the house itself).

Photo 1. Example of a bond wire

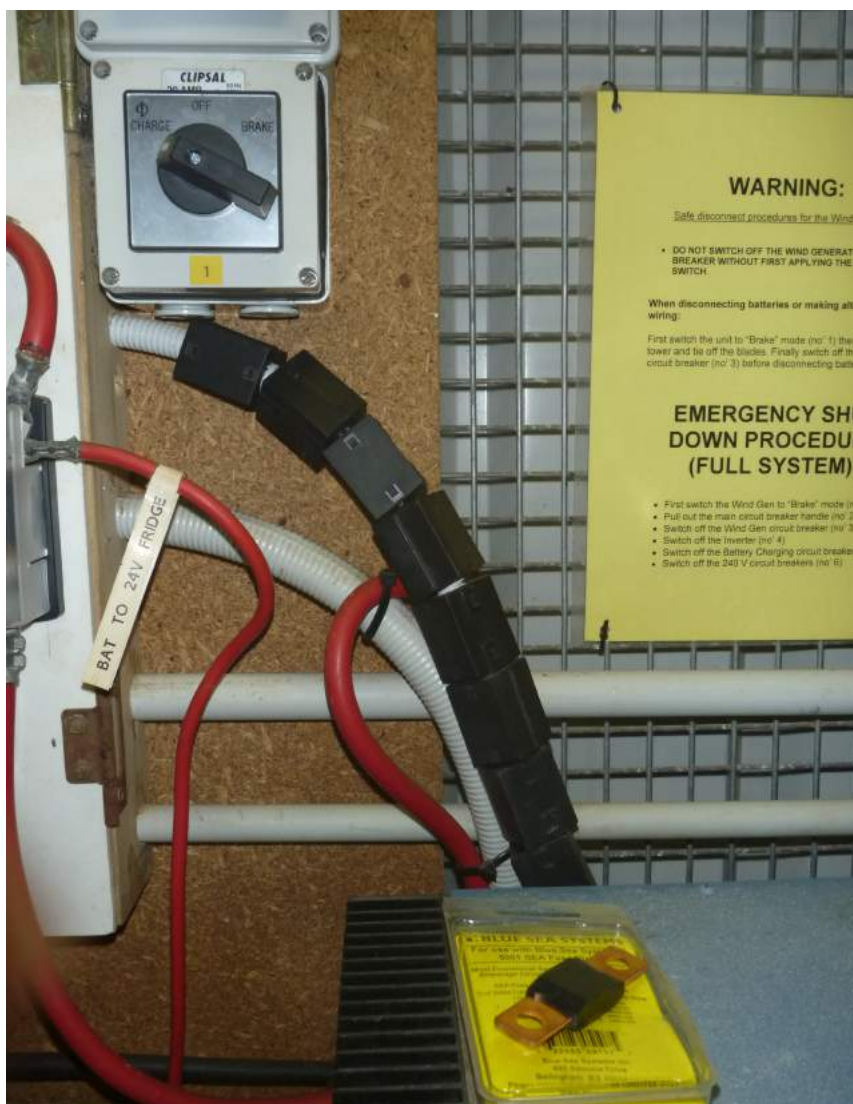
Photo 2. Setup of mains RFI filters on mains power lead

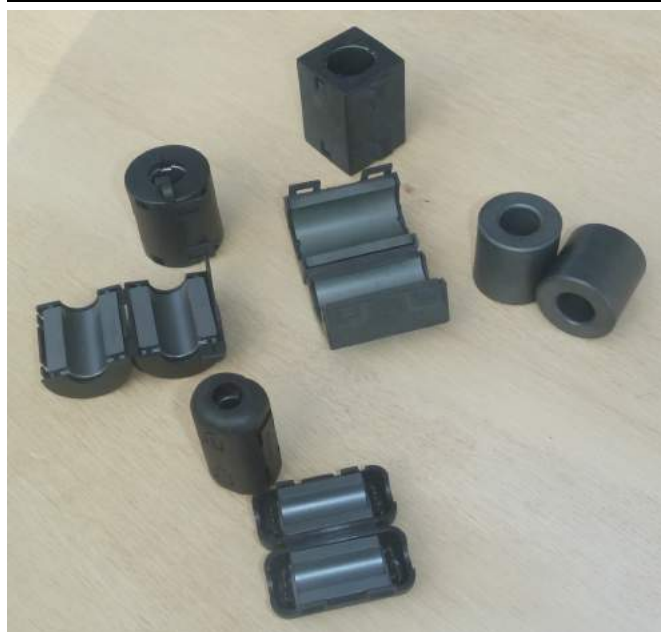
Photo 3. Examples of different EMI and RFI filters

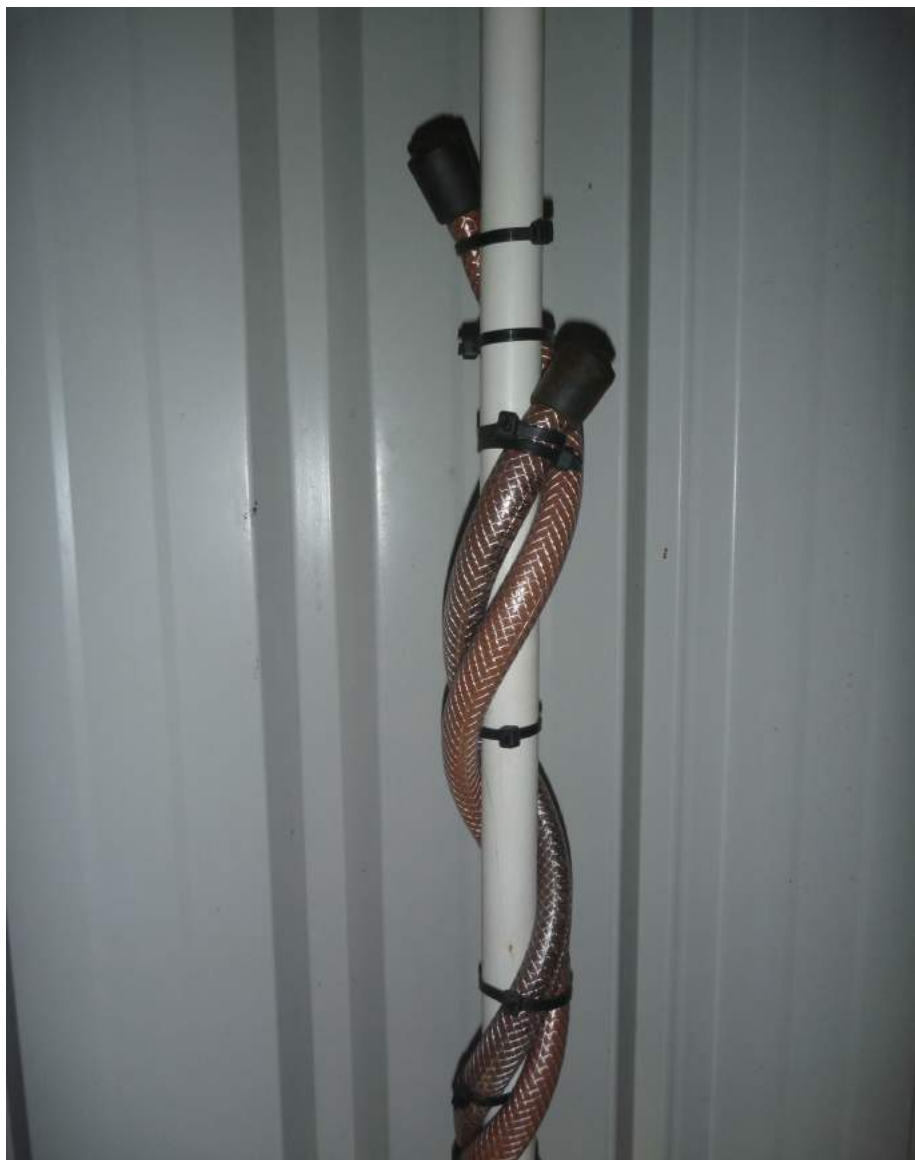
Photo 5. Home made ferric oxide RFI filter

To determine what spacing was best between multiple ferrite type RFI filters, I experimented by placing three together on a short extension lead then slowly moving them apart to see if I could detect any change in the level

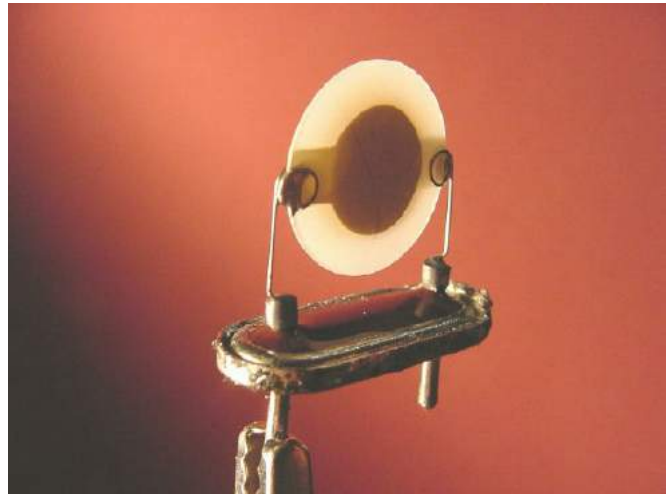
The HC6U base had 2 little springs with coiled ends. These were attached to the pins on the base. The crystal was inserted edgewise into the two springs, and secured. They were then put in a tray, and sent for final adjustment.

Picture 2: Crystal Mounting
