From the President	1	Aegis Remote Speaker Switch	29
HRSA Details	2	Stereo Amplifier	30
HRSA Activities & Disclaimer	3	The STC Shed	32
Society Notes	4	Ships' Wireless Receivers	35
First Official Wireless Message	5	Radio Picnic Competition Results	37
Repairing Handles	12	Letters to the Editor	38
Scharnberg Strauss Radio	13	From the Serviceman Who Tells	40
AWA Radiulette 500MY	20	HMV Model 660 (1940)	42
STC Model 831 (1941)	23	Magazines Received	44
New Members	44

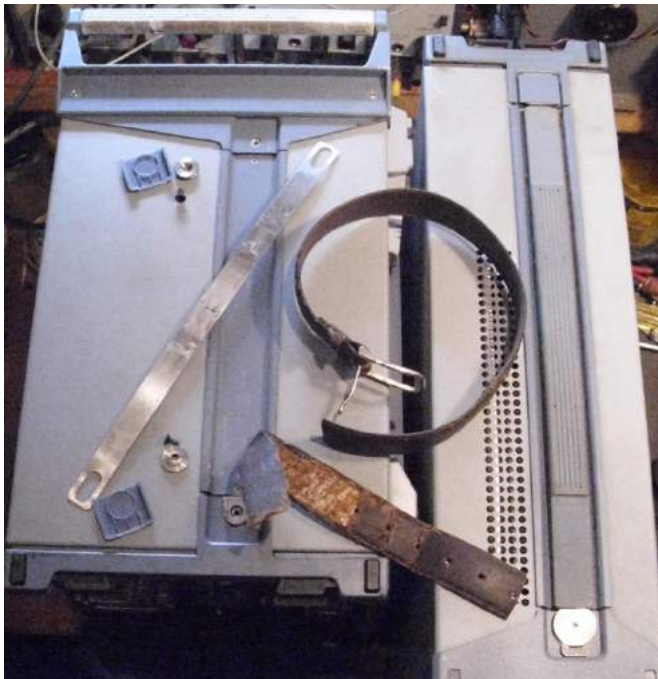
The handle consists of a metal strip with a plastic covering. The metal was still good, but the plastic was hard and brittle. The handle normally rested flush in a recessed cavity. When the handle was used, it flexed and the plastic fell off in small pieces. The photograph in Figure 1 shows, two test instruments, one with a good handle (on the right), and the remains of a handle (on the

Figure 1: Handle Metal Strip, Old Belt, Good Handle

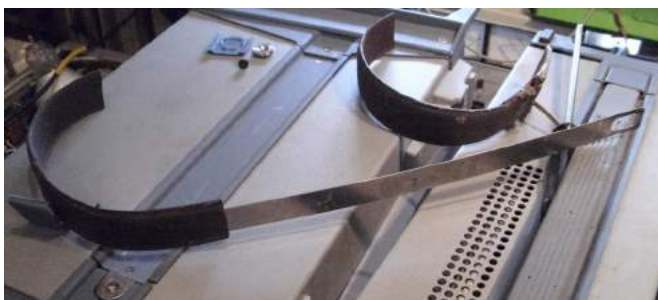
If you select a suitable belt, you can repair the handle. The belt must be long enough (of course), and be made of two pieces of leather, and sewn down each side. Cut the belt so that it is the correct length. Slide the metal

Figure 2: Sliding the Leather Belt on to the Metal Strip

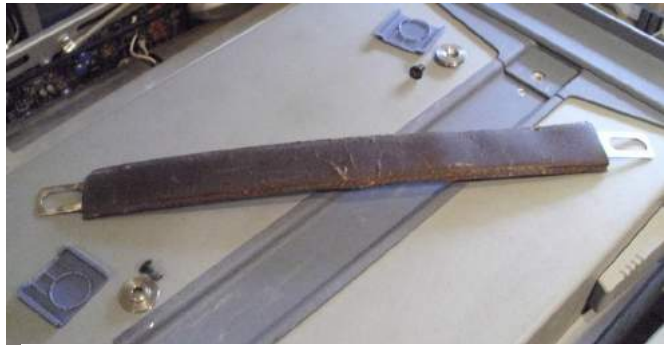
Figure 3: Finished Handle

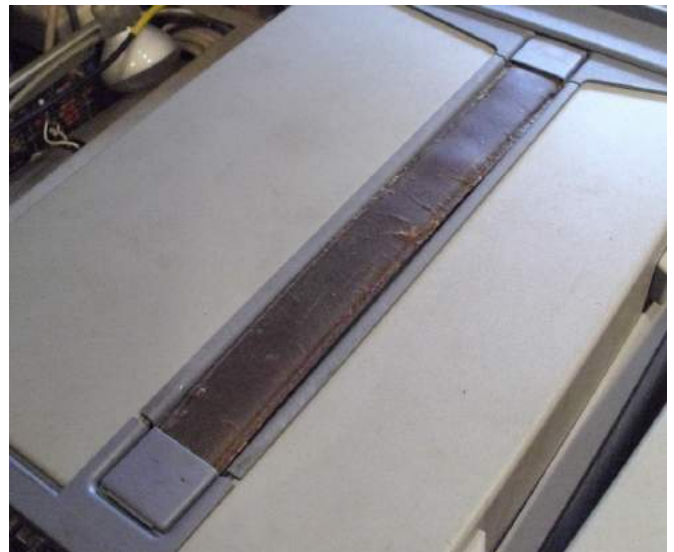
Figure 4: Handle Attached

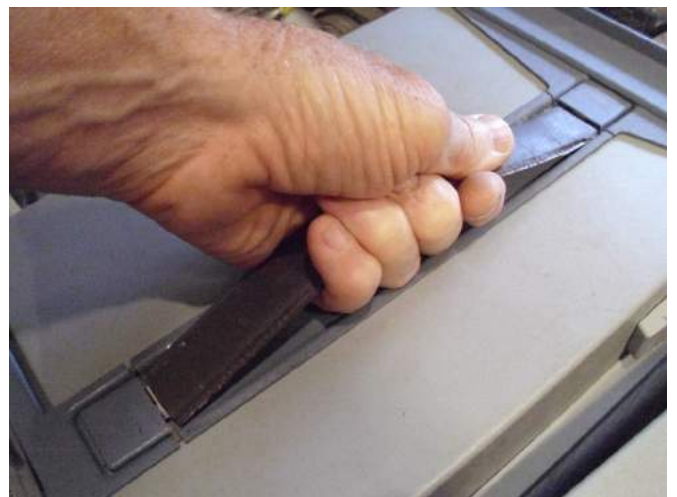
Figure 5: Handle in Use

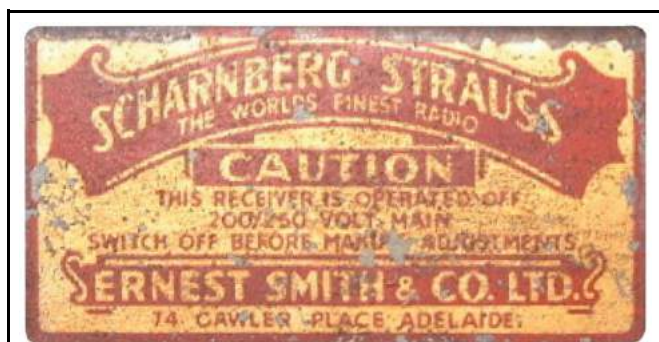
Label on the Scharnberg Strauss radio after the removal of the spray paint

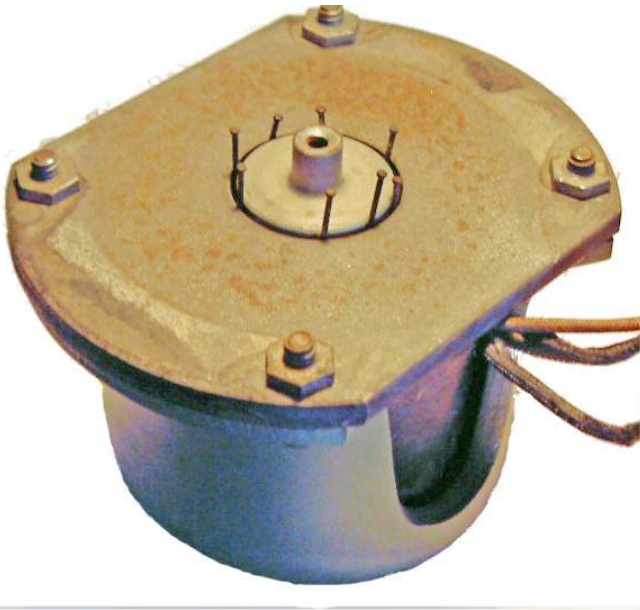
Speaker assembly, with pole clearance wire brads

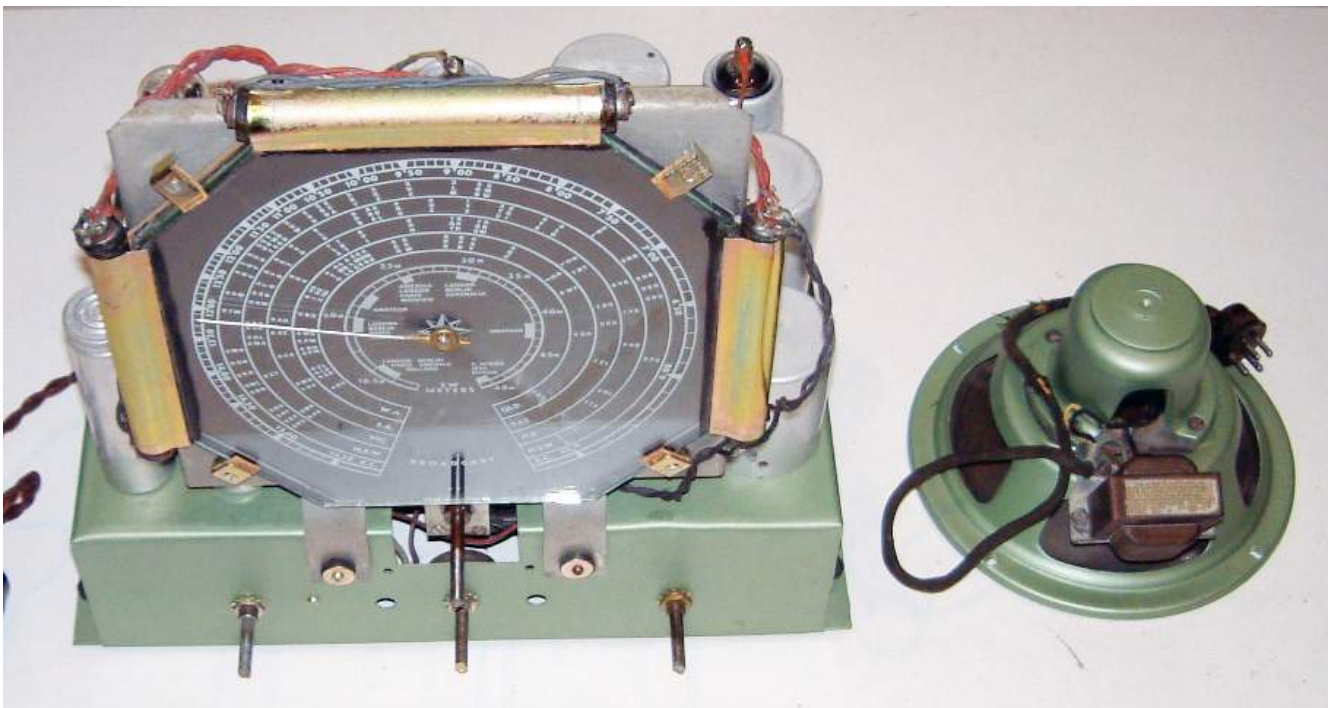
Restored chassis and speaker

I replaced each component one at a time and reconnected the wiring, and at the same time checking it against the circuit diagram. Most of the capacitors had previously been replaced with polyester circuit-board type caps. Once I had all the components in place and wired up, I then set about replacing all the capacitors with the more-correct axial-pigtail type which fitted better and looked considerable neater than the parallel-pigtail type. I took out earlier replaced Ducon electrolytic capacitors which were 16mfd instead of the design 8mfd, I also replaced the two 25mfd 50v electrolytic with 22mfd 63v.

The speaker transformer was open circuit, and from enquiries I found that I could get a replacement winding of the correct size (13/16" x 11/16" x 1") with the required 7000 ohms, 2 ohms. This I did instead of rewinding the original. After it arrived, I wondered which windings were which and how to connect it (in a positive and absolute way) to the original speaker cable where black and yellow disappeared into the electromagnet on the speaker, and the other two (green and brown), went directly to the speaker transformer winding. Was the latter the primary winding? How can you tell, can you distinguish which one it is with a multimeter? I decided to inspect the set wiring. The black and yellow went to the two fat pins of the plug at the back of the chassis,

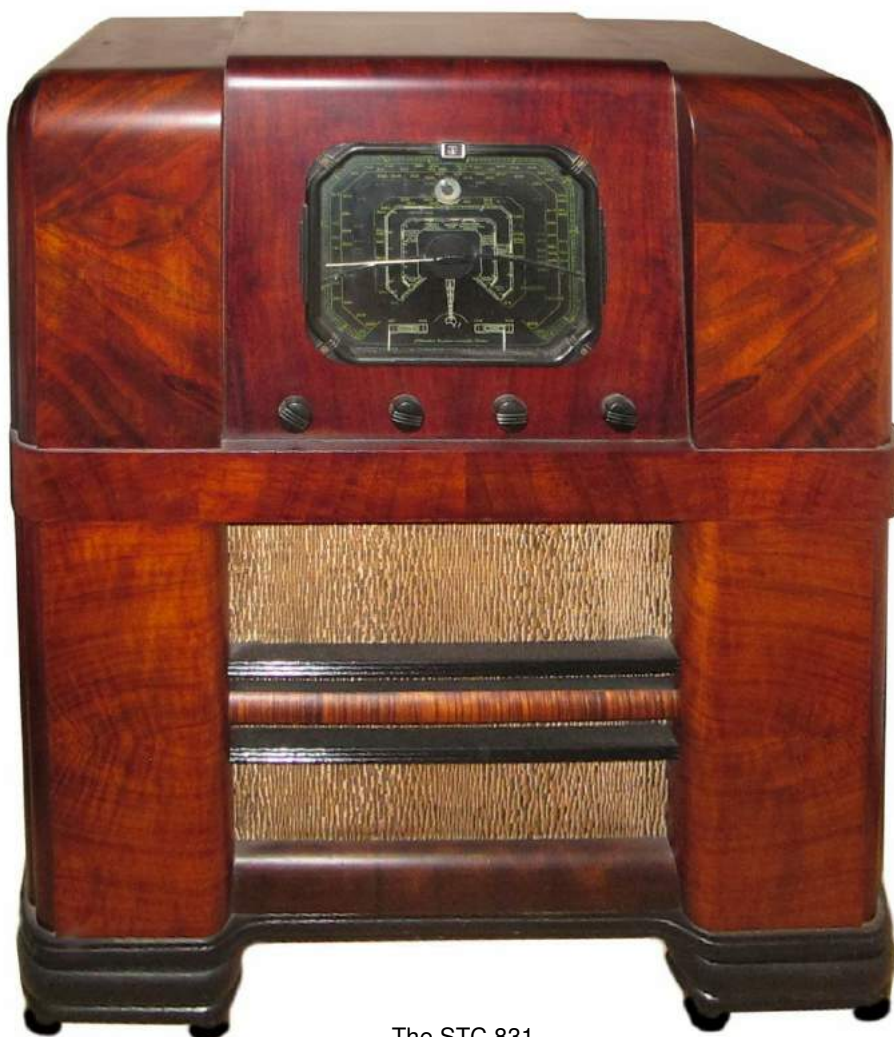
The STC 831

radio. More precisely No.7 refers to the number of electron paths that are subject to royalty payments. Most radios are licensed with No. 5 decals. The STC 831 is a top shelf design with nine separate valve envelopes. Unusually, the diodes for AGC and detection are in a stand alone 6H6 miniature octal valve. This small valve is

The top of the case was physically abraded and affected by heat from the valves, but otherwise the case was in reasonable condition. I stripped the entire case and lightly stained the centre section of abraded plywood with a Rosewood tint. The case was then finished with polyurethane.

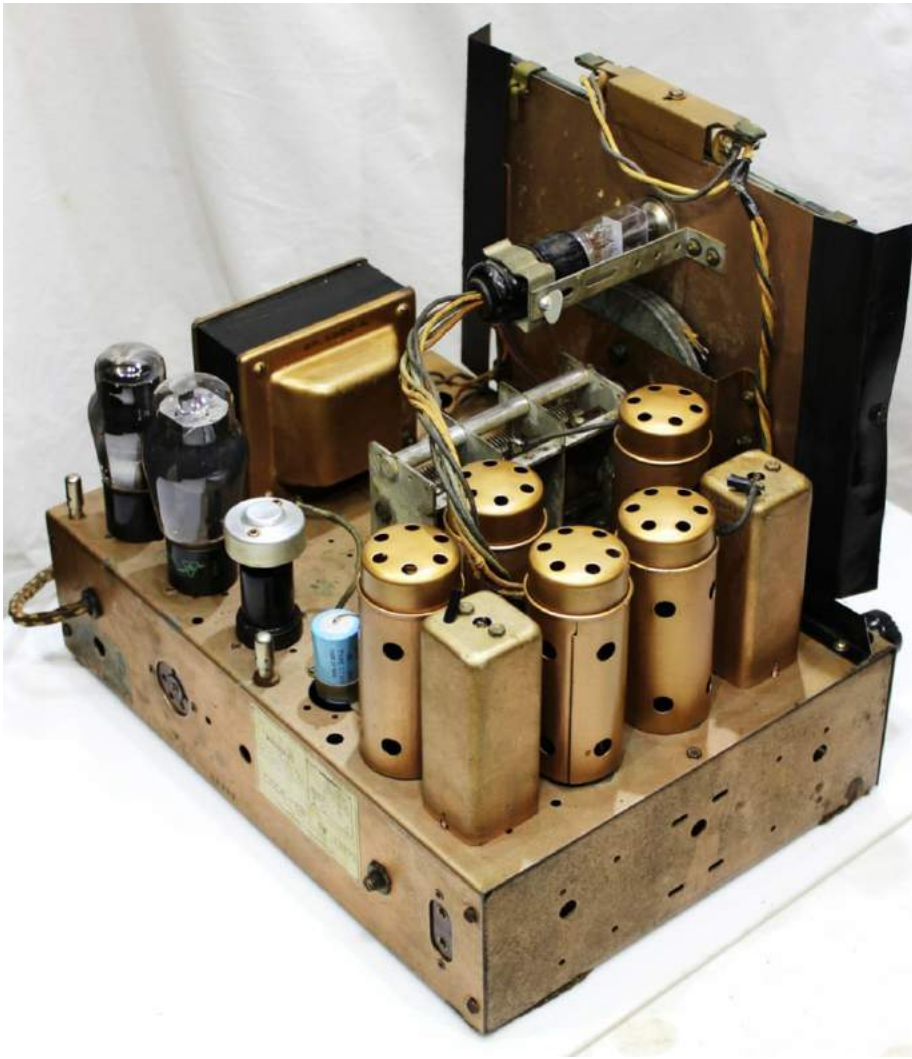
Oblique chassis view

off-the shelf wafers to perform the multiple switching tasks came in 4-position sets. The band switch on this radio was not always making solid contact first time when switching bands. After 78 years it is no surprise that some of the contacts became unreliable through corrosion and dirt. My response was to spray the contacts with WD-40. This spray lubricant has remarkable cleaning and penetrating properties and I had never encountered any problem when I had used it on other wave change switches.

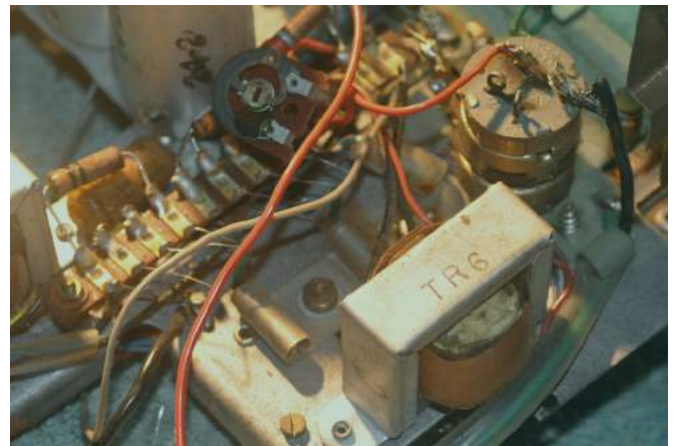
The bias pot setting was changed but it made no difference, making it a likely transistor problem. The tag board construction of this early Australian transistor radio made servicing easy. The untidy wire to the switch suggests some work has been undertaken previously.

The Kriesler 41-20's output stage

Both of the output transistors were removed as any replacement would require a reasonably matched pair.

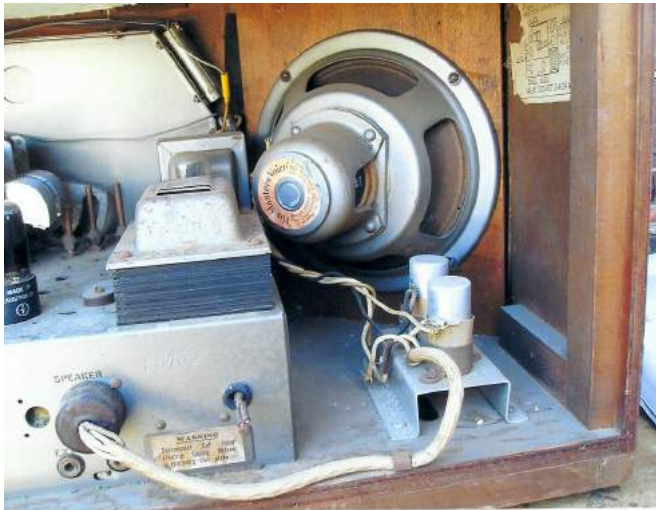
The radio includes some interesting items.

First, the cabinet was made so that the loudspeaker faces out of one of the corners. Perhaps this was done to reduce slightly the set's width and at the same time enable a decent-size speaker to be fitted.

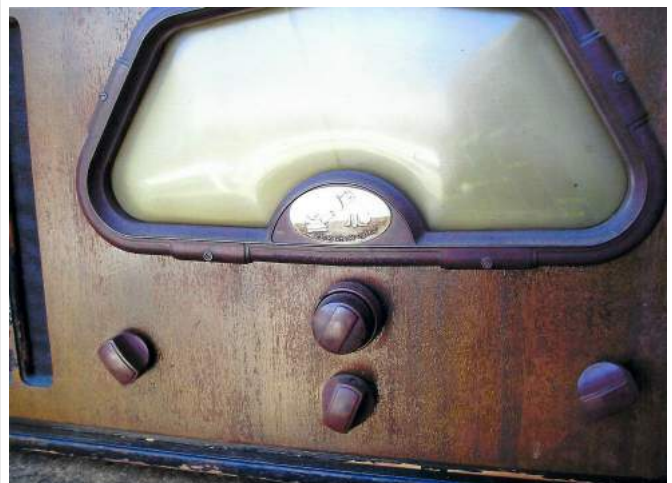
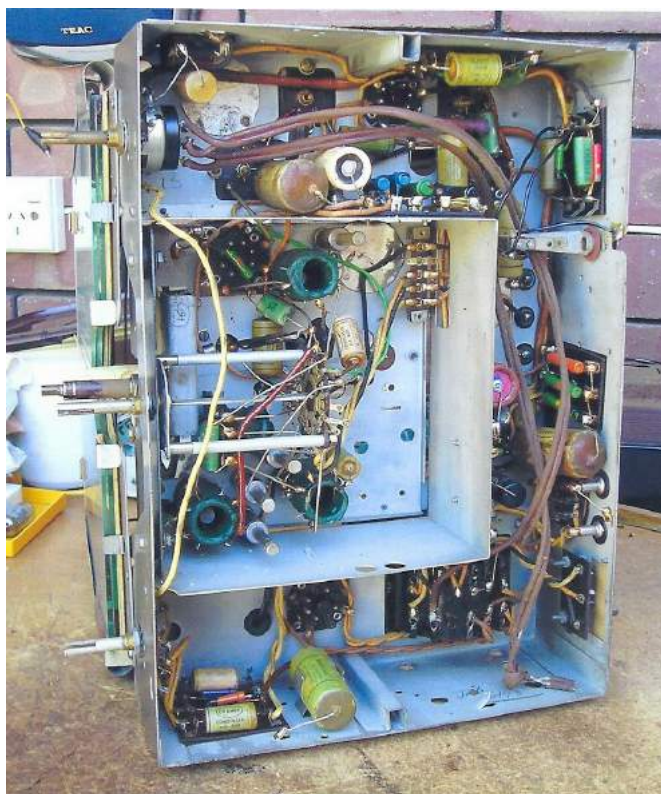
The dial glass was fitted with two sets of dial lights, with the printing of medium wave markings in one colour and those of short wave stations in a different colour. The wave change switch also changed the sets of lights so as to light up the appropriate markings. At night the dial is quite spectacular. Also written on the dial is a mark indicating space in the spectrum for future AM stations.

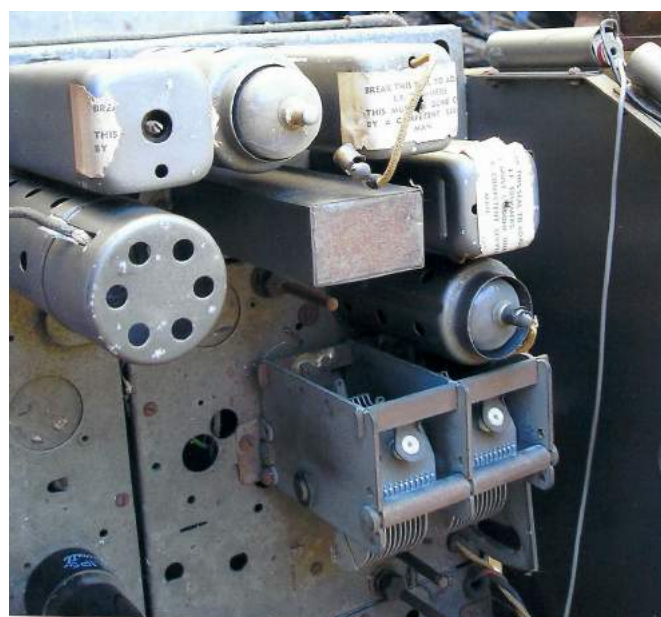
Another interesting feature of the set is the use of component boards for sections of the circuit. Some of these boards can be seen in the photo of the underside of the chassis. The boards and their components are shown in the circuit diagrams in the *Australian Official Radio Service Manual*. It does appear that HMV was one of the first to use such boards. Several HMV sets from 1949 used such boards in their wiring.

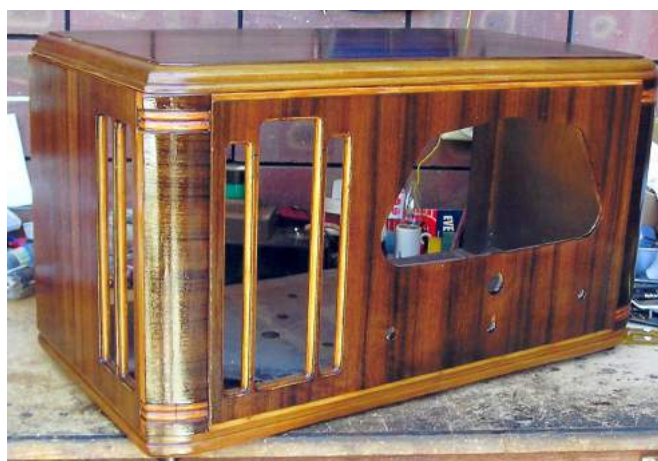
While the cabinet was in a bad way (storing in a shed does not help) the chassis looked in good condition. Even the instructions on the adjustment of the IF transformers were intact. Inspection showed a large value and large size paper capacitor. This and similar components were replaced. As well, the electrolytic capacitors were

replaced and fitted on the same mini-chassis as the original ones. Since the original power cord had become brittle with age, it was replaced with a new, 3-core cloth-covered one that looked in keeping with the age of the set.

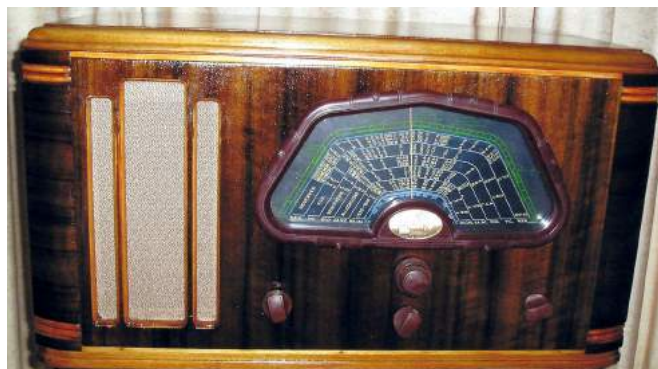
The finished product

The original treatment of the cabinet included black paint to cover the end grain of some of the woodwork, but the paint had deteriorated to the point that had to come off. The idea of having to mask each trim was a bit much, so the remainder of the black was removed. I then decided to coat the whole cabinet as you see it in the photograph.

It is fair to say that the result is a spectacular looking and excellent performing radio.
